HEALTH REPORT

MARIARI GIRLS KDG 903C

JALFSR90NN7000053

10,811 km

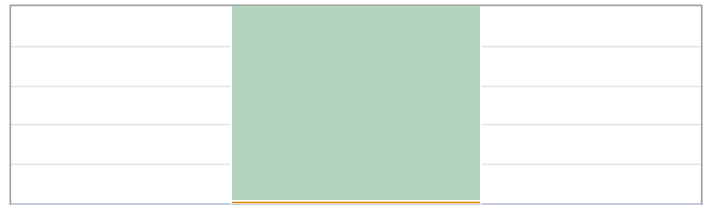
The distribution of acceleration for this vehicle is within the typical range. Get inspections and maintenance according to the other report items and the Owner's Manual.

Distribution of acceleration A/O* (Acceleration Operation)

A/O* not sensed by passenger
A/O* not discomforting to passenger
Sudden acceleration
Total acceleration (times)
Total sudden acceleration (times)

1st time
98.53%
1.46%
0.02%
807,491
122
